Alliant Power has recently become aware of a number of counterfeit HEUI cores circulating in the marketplace. If encountered, we ask that you contact the Alliant Power Technical Support department immediately. This bulletin provides details on how to identify counterfeits.

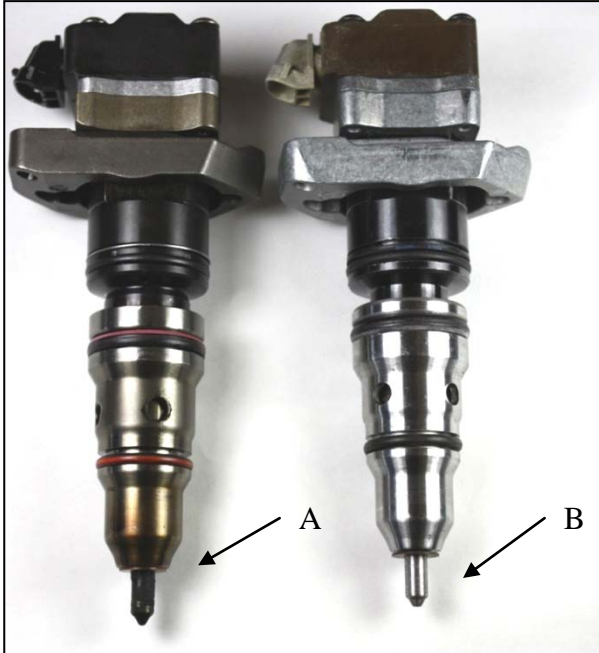
Figure 1 depicts a genuine injector (A) and a counterfeit (B). The counterfeits closely resemble actual injectors, both in appearance and weight.

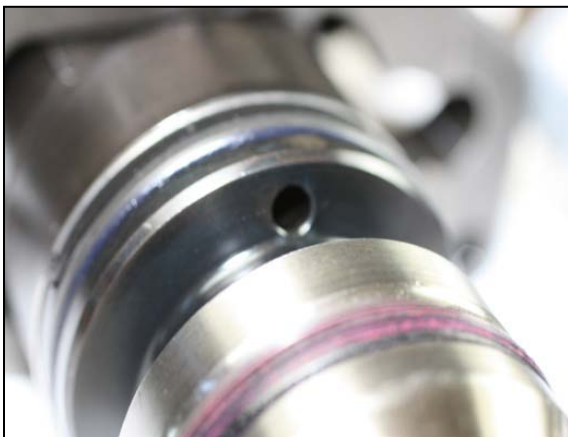
Figure 2

The quickest way to identify a counterfeit core is to examine the body of the injector to determine the presence of an oil inlet port. **Figure 2** shows the oil inlet port on a genuine injector. **Figure 3** shows a counterfeit (which has no oil inlet port).

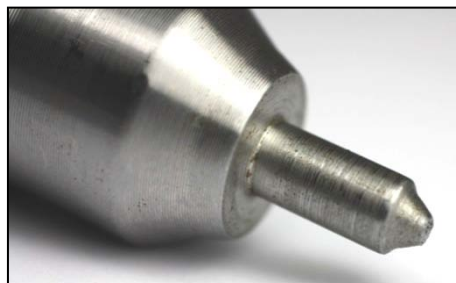
Figure 4

Additionally, a close look at the tip of a counterfeit injector reveals there are no spray holes and that the tip and nozzle nut are one piece (**Figure 4**).

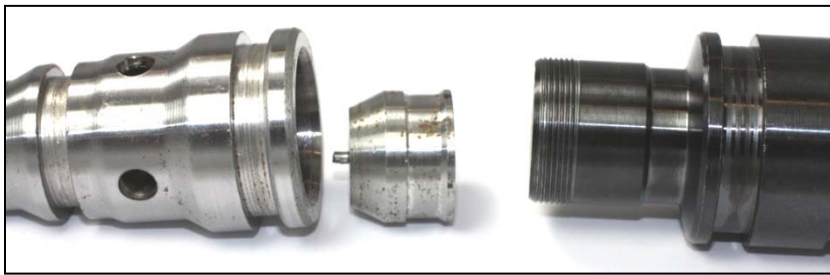
Figure 5

Figures 5, 6, and 7 depict a disassembled counterfeit injector. From these images it is easy to see that there are no functional internal components.

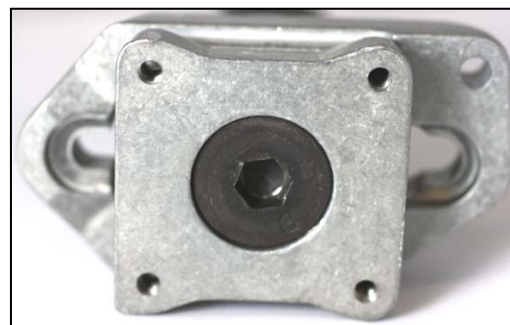
Figure 8 shows a counterfeit injector with the solenoid removed. The injector hold down clamp is also visible. This clamp on the counterfeit injector is made of aluminum as opposed to the steel clamp that is found on genuine injectors.
